# Corrosion Evaluation of HPS Bridges in Tennessee

Desmond Cook (member HPS-CAG)  
Old Dominion University  
Norfolk, Va 23529  
[www.physics.odu.edu/dcook](http://www.physics.odu.edu/dcook)  
[www.RustDr.com](http://www.RustDr.com)

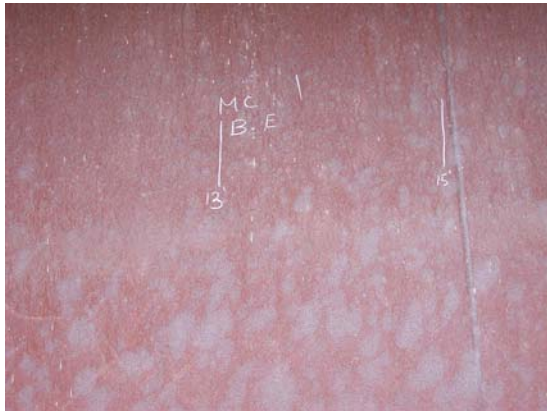
Facias

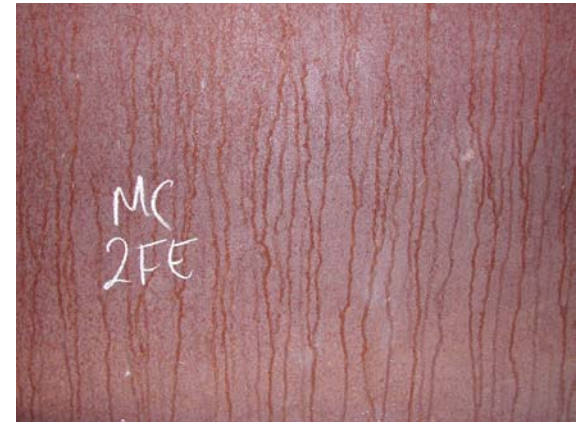
Interior Webs  
(over water)

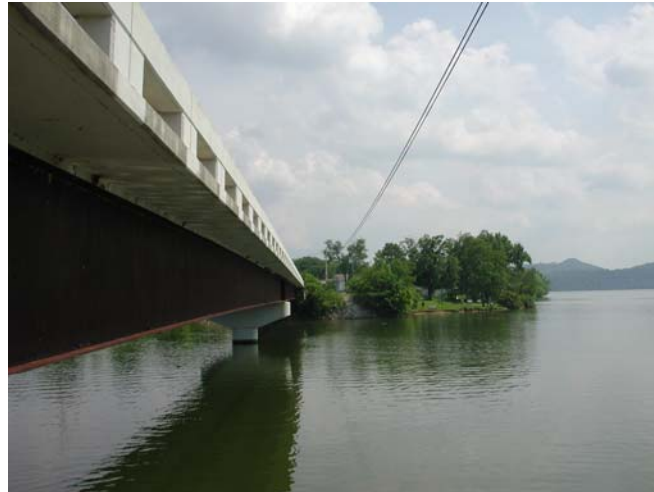
Drainage

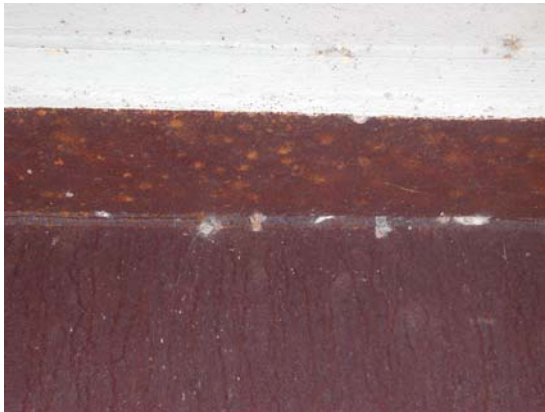
Upper Flange

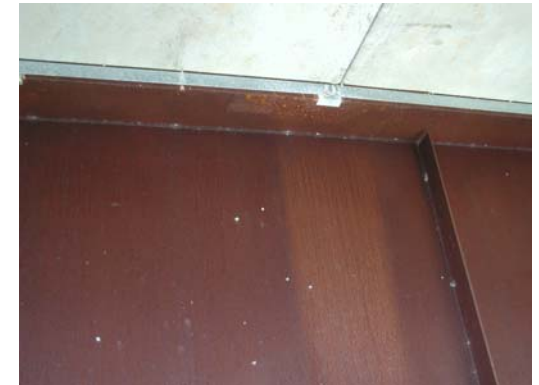
Water leak

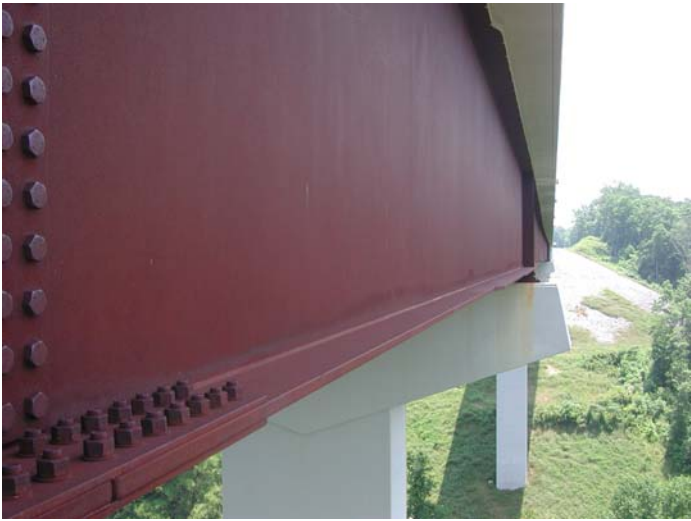
Fascias

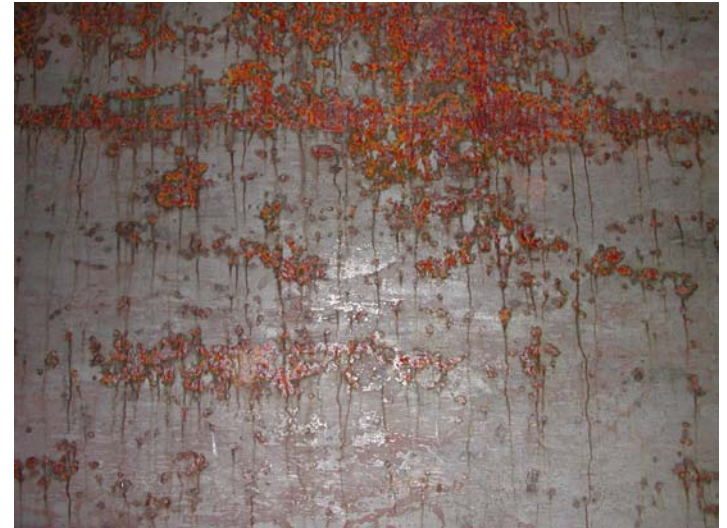
- Abutments (50W): Goethite 45%, Lepidocrocite 55%, Maghemite 0%
- Pier 2: Goethite 50%, Lepidocrocite 50%, Millscale (lots on interior girders)
- Goethite broad peaks>>>>> small particle size (protective)

Millscale

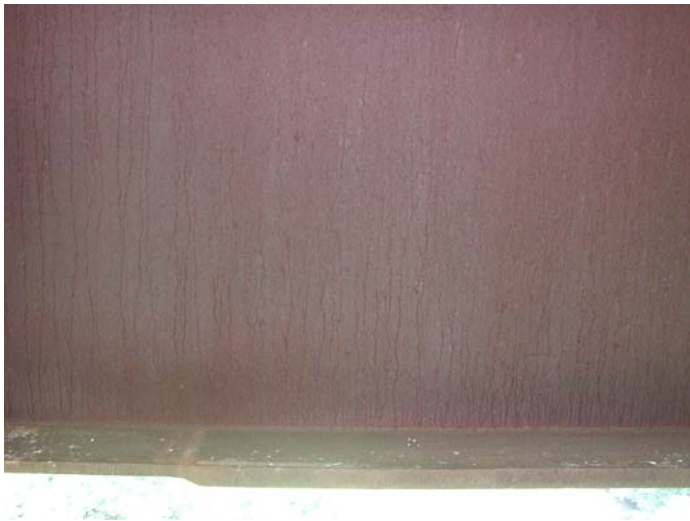
Condensation

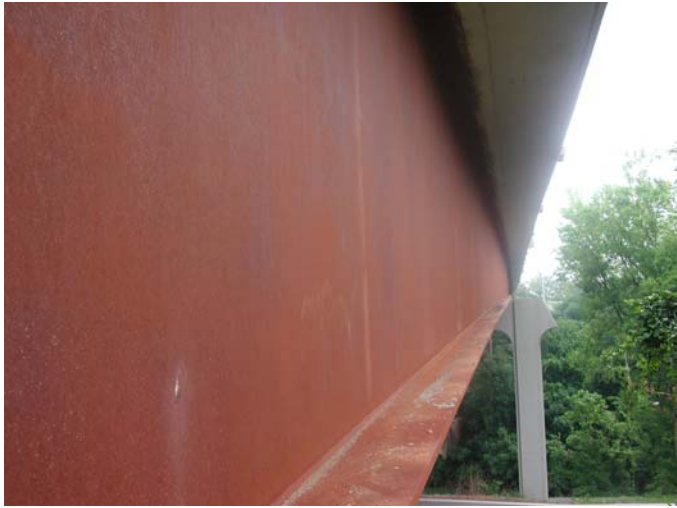
Fascias

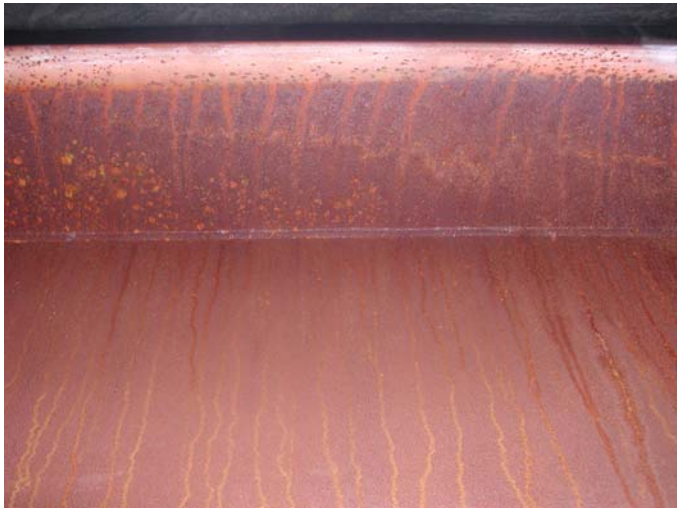
Condensation/leakage

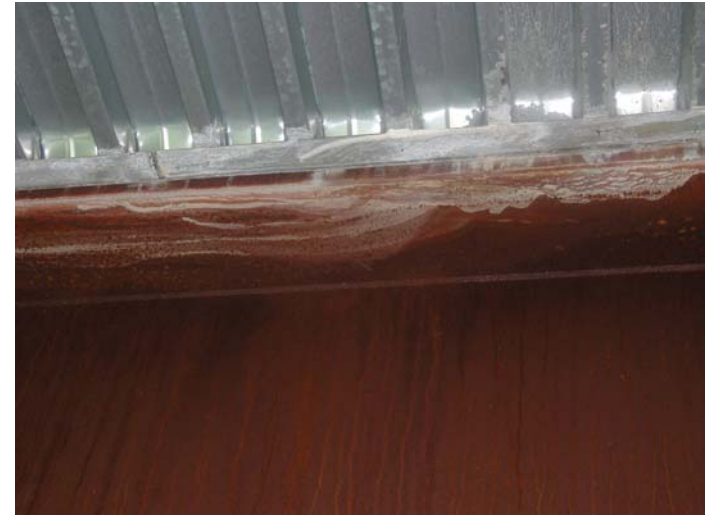
Paint

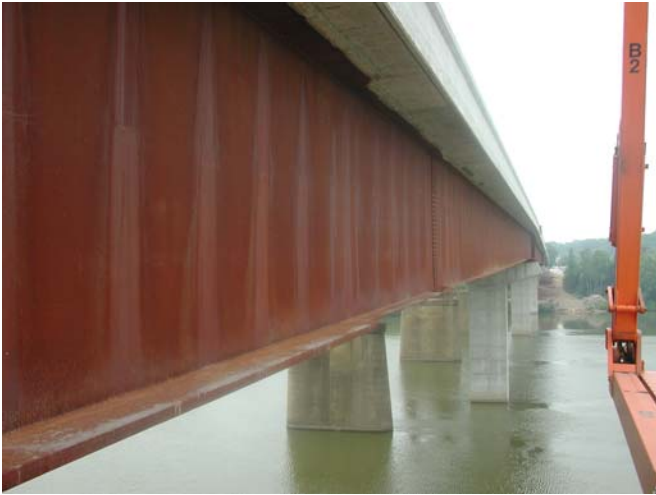
Fascias

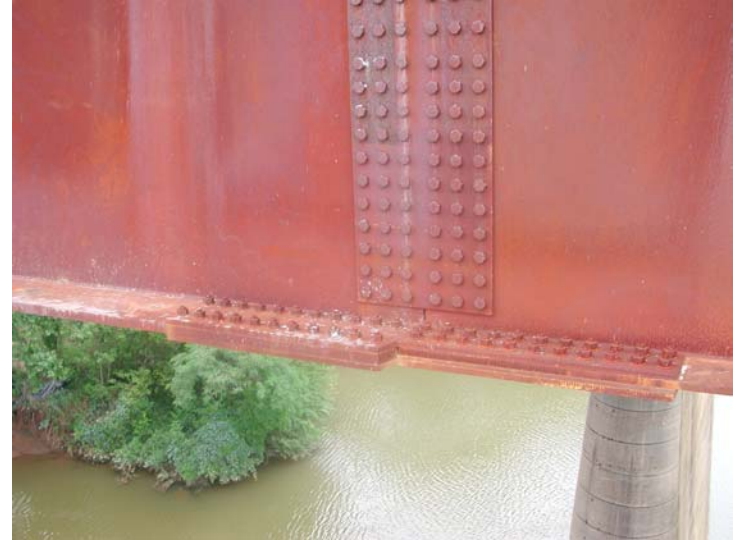
Grade 50W<<<Splice 2>>HPS 70W

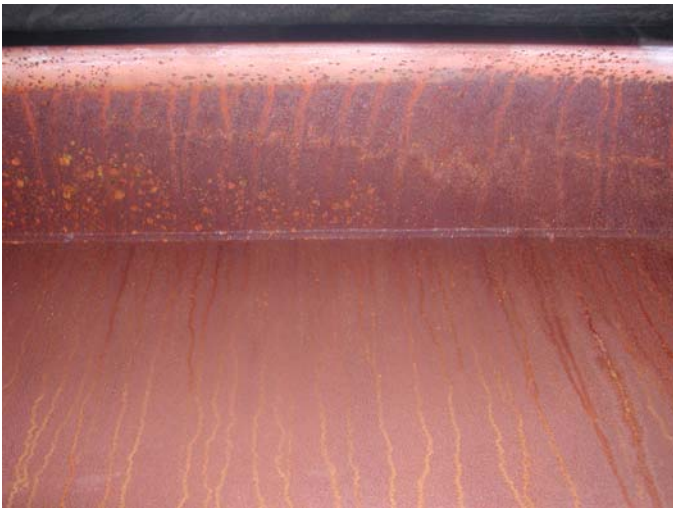
Condensation/leakage

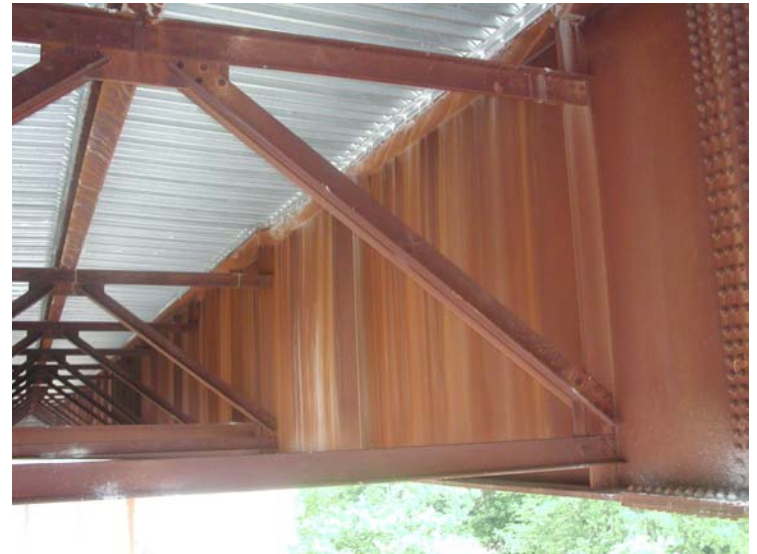
Paint/Leakage

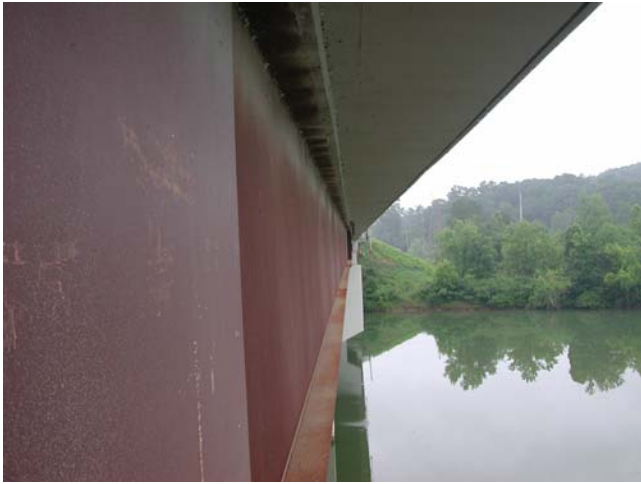
Fascias

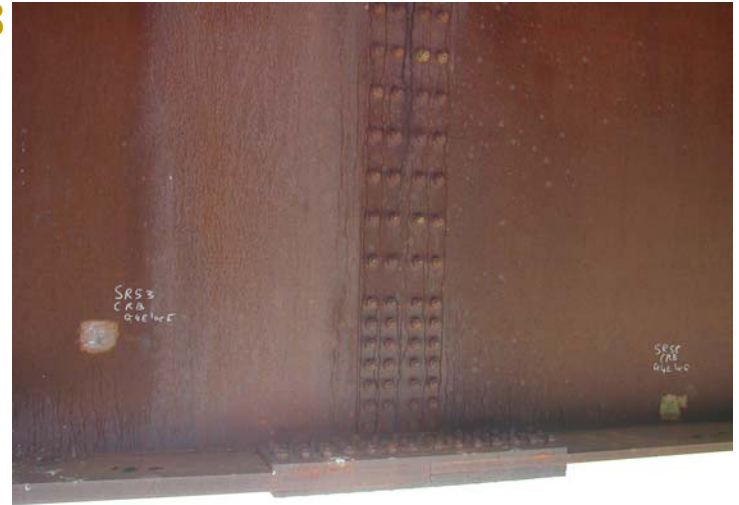
**Grade 50W<<<Splice 3>> HPS 70W(TMCP)  
HPS 70W (Q&T)**

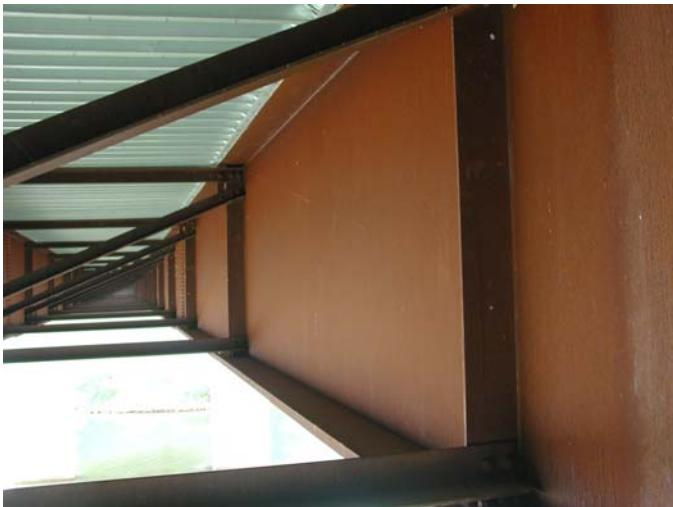
Interior girders
